# Delamination

# Poor Bond of Impression Material to the Tray

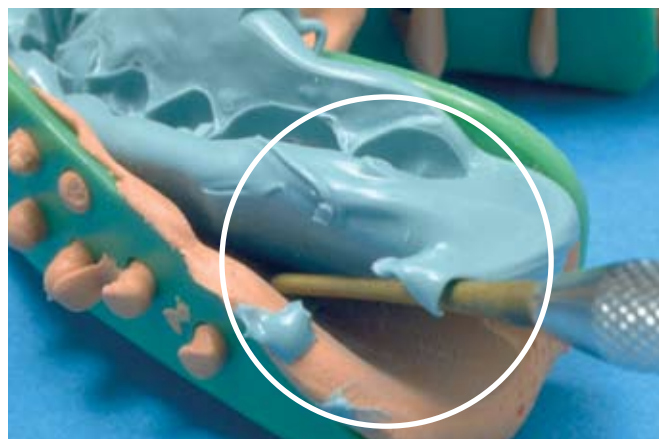
**Visual Appearance:** Heavy body and light body materials not blended, or mixed together.

**Result:** Restoration will not seat or fit properly.

CAUSE	SOLUTION
Exceeding the working time.	Follow manufacturer's working time specifications.
Impression material stored at elevated temperature.	Choose material with longer working time. Store impression material at room temperature.

VPS	SOLUTION
Sulfur or acrylic contamination of pre-set heavy body material in two-step technique.	Avoid contact with sulfur contaminants: Wear gloves proven not to contain traces of sulfur.  Avoid contact with acrylic and methacrylic contaminants: Ensure impression material does not come into contact with methacrylate residue from acrylate temporary materials.

**Poor Bond Between Heavy Body and Light Body Material**

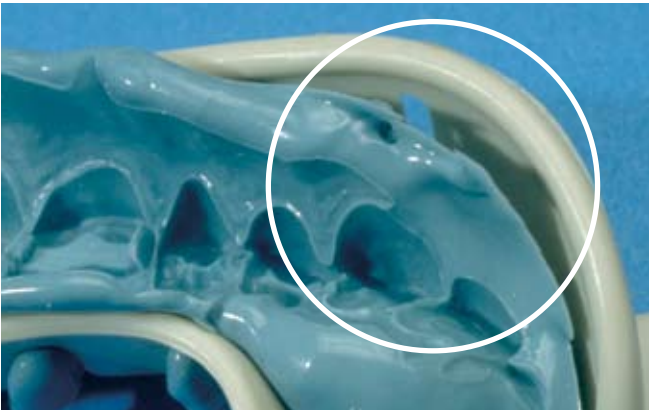
**Visual Appearance:** Impression pulling away from the sides/bottom of tray.

**Result:** Crown(s) may be tight and not seat fully, or require excessive internal adjustment.

No tray adhesive used.

Incompatible tray adhesive used.

Inadequate drying time for tray adhesive.

Thin plastic trays allow deflection, which can cause rebound upon removal.

**Separation of Material from Tray**

Use tray adhesive.

Use appropriate tray adhesive. VPS adhesive for VPS. Polyether adhesive for polyether materials.

Follow manufacturer's instructions for application, and drying time.

Use a tray that fits better, and is stiffer and more rigid.
