# Inhibited or Slow Setting

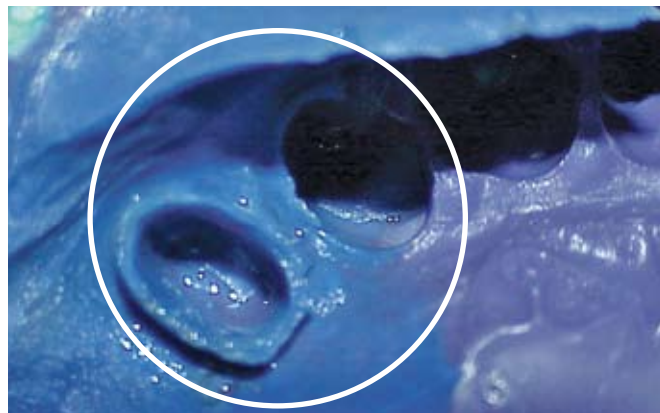
**Visual Appearance:** Impression not completely set. Shiny, no detail of site.

CAUSE	SOLUTION
<b>For Vinyl Polysiloxane Materials</b> Sulfur inhibition due to contact of latex gloves with tissue/tooth/retraction material or impression material.	Wear gloves proven not to contain traces of sulfur. If contamination is suspected, scrub affected area with diluted hydrogen peroxide.
Residues from custom temporary or provisional cements (acrylics) present.	Do not use impressions already used to fabricate the temporary restoration. Fabricate the temporary crown or bridge after final impression has been made. Remove air-inhibited layer on the exposed surface with an alcohol wipe before making final impression.

**Inhibited Setting**

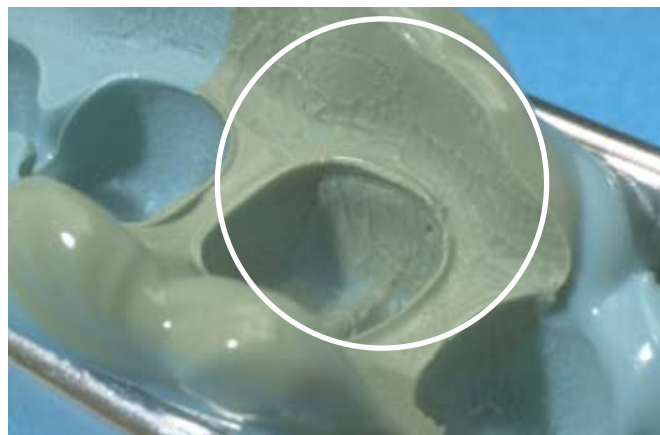
**Surface Inhibition**

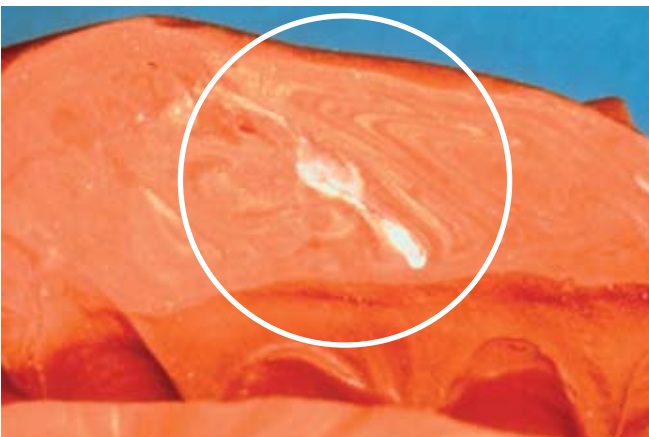
Inadequate mix.

**Inadequate Mix**

Bleed before applying mix tip to ensure even dispensing.

Use mix tip according to manufacturer's instruction for use.

Ensure mix tip is correctly attached.

When using hand-mix materials ensure correct mixing ratio and thorough mix of catalyst and base paste.
