Voids on the Margin

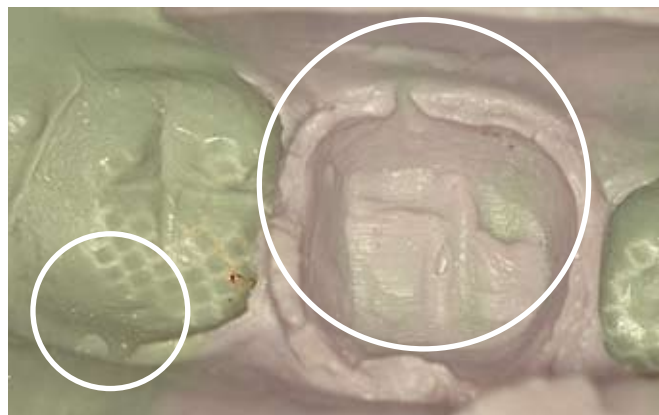
Visual Appearance: Voids/holes on margin of the prepared teeth. Incomplete margin.

Result: The fit and function of the final restoration may be compromised. Short crown margins and/or open margins.

Void Caused by Syringe Technique

CAUSE	SOLUTION
Air trapped in intraoral syringe.	Properly bleed filled elastomer syringe. Keep tip immersed in material when loading syringe. Do not stop when in the middle of loading syringe.
Air trapped while filling impression tray.	Keep mix tip immersed in tray material while filling the tray.
Improper syringe technique.	Keep syringe tip immersed in wash material to avoid entrapping air. Wiggle and stir while syringing. Push material forward.
Inadequate coverage of marginal area with light body impression material.	Use wash material liberally on preparation and abutments.

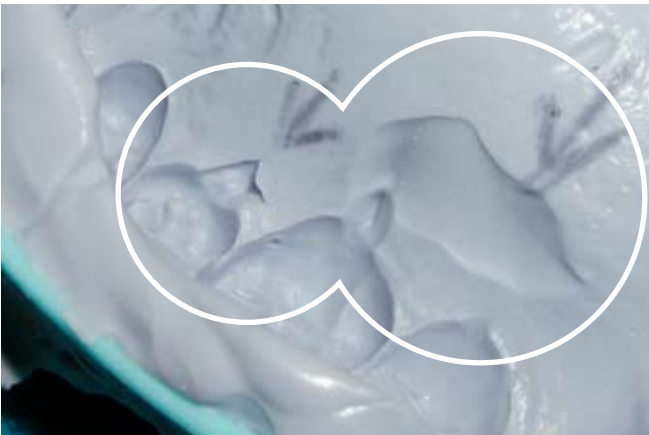
Blood and saliva contamination around prep.

Trapped Air or Moisture

Use good moisture control technique. Rinse and dry prep area before taking the impression.

Stop bleeding by using appropriate retraction technique and hemostatic agent. Leave cord in sulcus until no blood or saliva are present before syringing the light body impression material. Consider two-cord retraction to displace tissue and control fluids.
